## Case Study – managing waste rock and tailings at Cadia Valley Operations gold mines

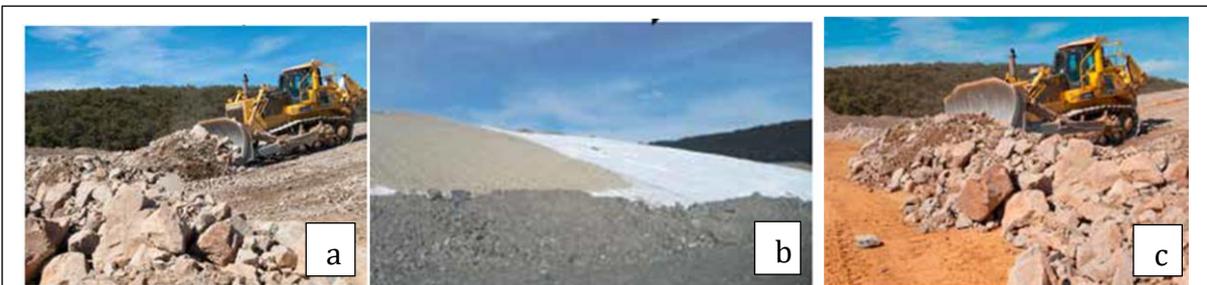
Figure 2 (a) waste piles are contoured to less than a 18° slope, (b) HDPE and compacted clay layers seal the waste, and (c) inert rock and soil are placed on top of compacted clay (from Cadia District Heritage & Recreational Area Guide Book)

Challenge	Management strategy	Rationale
Large volume of waste rock and tailings	Manage waste on site	The large volume of waste requires management on site.
Erosion of steep rock piles	Contour waste piles (Figure 2a)	Gentle slopes are less susceptible to erosion.
Acid drainage	Seal rock dumps with high density polyethylene (HDPE) liner material topped with 0.5 m of clay (Figure 2b)	Sulfuric acid is produced when sulfide ores react with water and oxygen. Two layers of sealant provides extra protection to ensure that waste does not react with water and oxygen.
Habitat loss	<b>Waste Rock</b> Top clay-capped dumps with 2 m of inert waste rock and 0.2 m of topsoil (Figure 2c); plant with native seeds; construct artificial wetlands	A thick layer of inert rock and soil on top of the capped dump allows growth of trees without root systems damaging the integrity of sealant materials. Native seeds from the area are planted to restore an appropriate ecosystem. Artificial wetlands provide habitat and treat water containing residual mineral waste.

The North Waste Rock Dump contains more than 30 million tonnes of waste rock covering an area of 66 hectares. It was rehabilitated and seeded in 2013 (Figure 2). Some revegetation can be seen in the overview of the site shown in Figure 1.

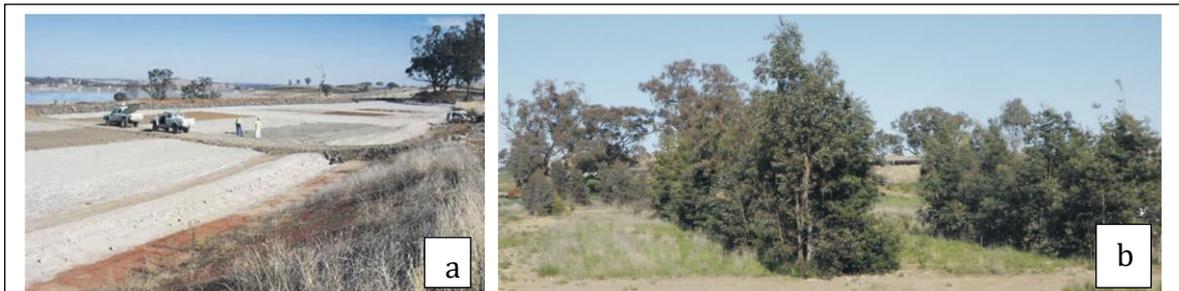
Figure 3: Tailings revegetation trials. (a) Construction of plots for rehabilitation in 2004. (b) Significant growth of vegetation seen in 2010, despite drought. (provided by Newcrest Mining Ltd)

Mine tailings are very fine sediments that are pumped with water into containment dams. Experiments on site demonstrated that it was possible to grow pasture grass in pure tailings with fertiliser. A much better result was achieved with use of topsoil and/or biosolids. Native vegetation grew through drought conditions and demonstrated seeding in the experimental tailings plots (Figure 3). An important finding was that plant roots penetrated up to 2.5 m into the tailings. This increases stability for the land over time and bodes well for rehabilitation.
